VIKING LANDER MOSAICS

VIKING LANDER 1 RECTIFIED PHOTOMOSAIC EVENING SCENE - CAMERA 2 - SECTOR 1

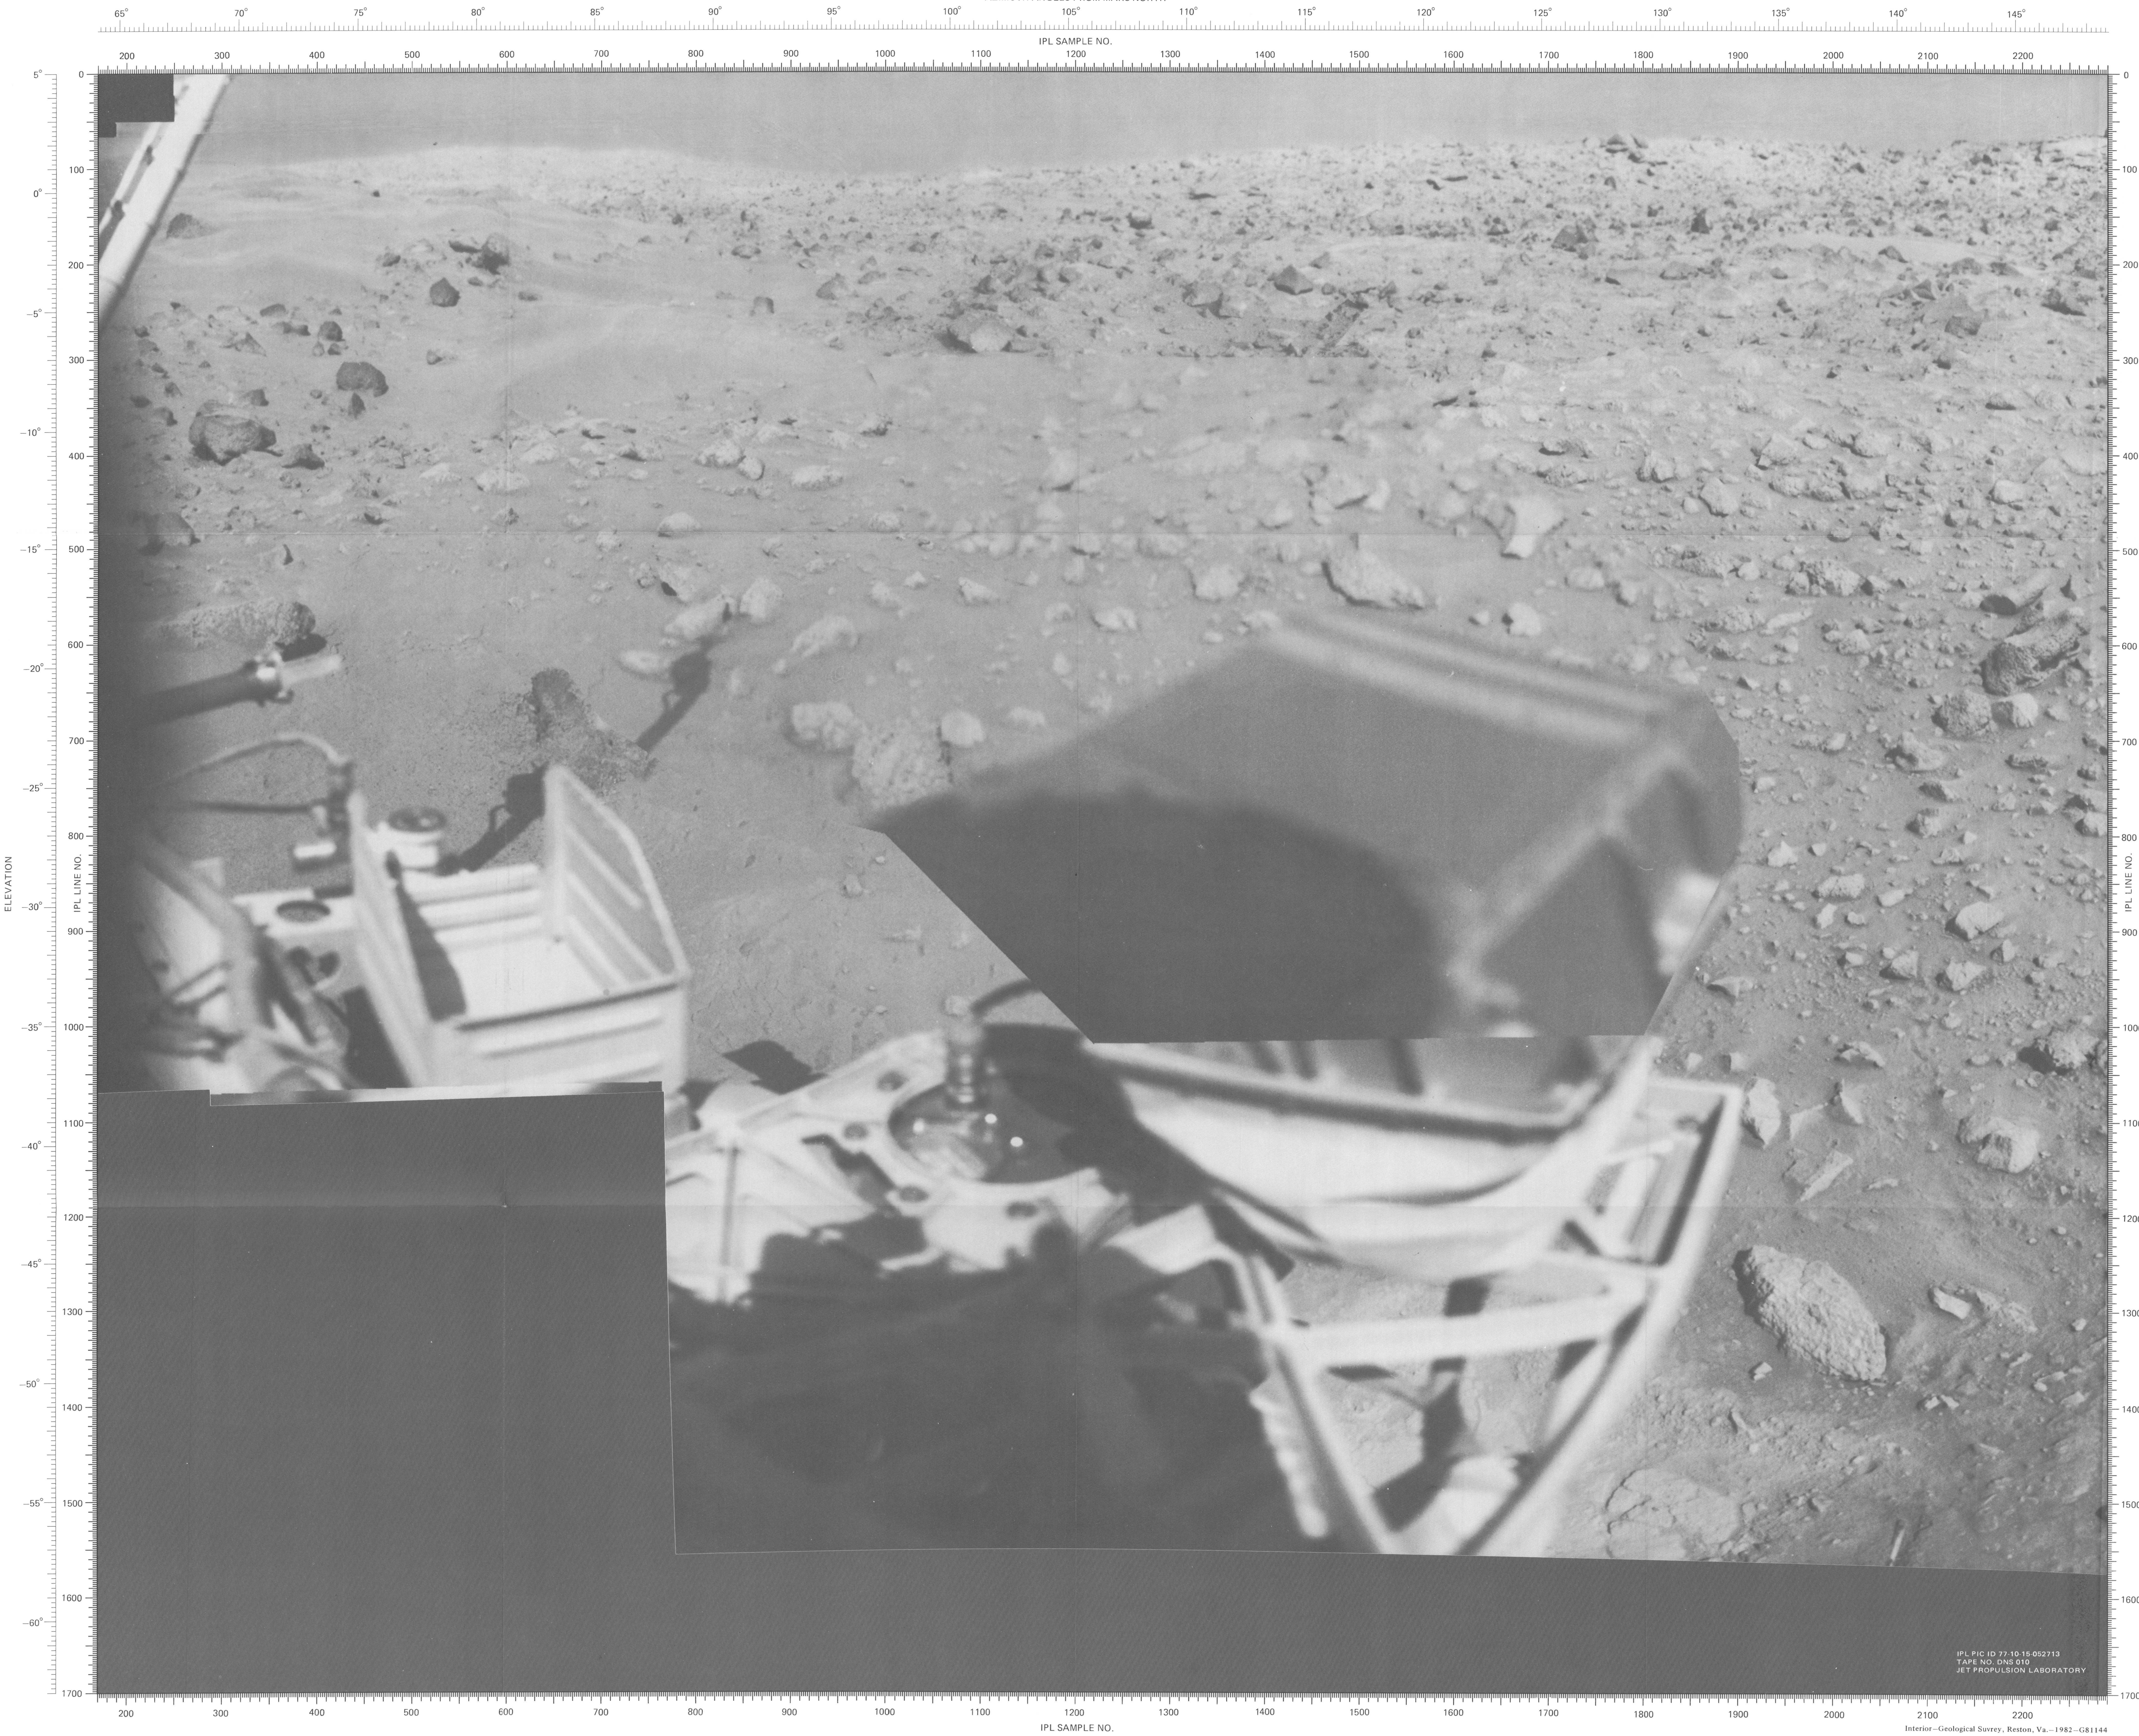
At the left in this view east from the lander, a field of drifts of very fine grained material dominates the scene. This material probably covered the area as a thick blanket and was subsequently stripped off by the wind; patches of the material were left behind in the form of drifts scattered among the blocks that litter the landscape. The ridge that forms the horizon above the drifts (line 80, sample 700) lies about 1.18 km from the lander. The angular blocks that cover the surface range in size from a few tenths of millimeters to over 1 m.

Parts of the lander are visible in the lower right. The large object at the center of the scene is the surface sampler in its stowed position. Only the back of the instrument housing is visible in the mosaic of two pictures that include it. Most picture-taking sequences for the Viking cameras were planned to avoid parts of the lander, except for the surface sampler, and to image as much of the surface as possible.

At the lower left (line 650, sample 650) just above the lander is a trench dug by the surface sampler to obtain specimens of the martian soil for analyses by instruments on board the lander. The soil was analyzed for biologic activity and for organic and inorganic content. The trench, about 85 mm wide, was dug in a drift of the very fine grained material. During landing, one of the footholds of the spacecraft was buried in this drift. At the lower right, (line 1550, sample 1750) exhaust from the retro rockets has swept away fine-grained material from beneath the lander during its landing maneuvers and has exposed a firm layer of "disrupted". The bright cylindrical object (line 1550, sample 2060) is a latch pin that secured the surface sampler until after landing. The latch pin was released by an extension command to the surface sampler and fell to the surface before the instrument began its sampling activities. The pin is 6 mm in diameter and 82 mm long.

The cameras on the Viking Lander acquire data by sampling in equal increments of elevation and azimuth angle. In the accompanying mosaic, 8 mm subtends a 1° horizontal or vertical angle, regardless of the place of measurement within the panorama. If the martian surface were flat, one pixel (0.04°) on the surface would be 1 mm wide at 60° camera elevation and 2 m wide at the horizon 3 km away. Characteristically for this type of imaging system, most straight lines in the scene appear curved in the reconstruction. This representation of the picture data differs from that of a com-

The geometry of the Lander pictures is complicated by additional factors. Because both landers are tilted with respect to the horizon, on the uncorrected pictures the horizon resembles a sine curve. Computer rectification of the pictures results in a straight horizon along which vertical angles can be measured with respect to the local gravity vector, and horizontal angles can be measured from martian north. These angles are not related in any simple way to the azimuth and elevation angles given in "camera coordinates" for the unrectified pictures.

There are other geometric distortions due to the cameras: optic path distortion that affects a light ray after it passes the camera windows, and camera-system distortions, "roll-down" errors, that are caused by the way the cameras are mounted on the lander. The geometric transformation used in creating the mosaics took into account the optic path distortion but not the "roll-down" errors. However, along the horizon, the error in azimuth angle is equal to the rotational "roll-down" error for each camera to an accuracy of less than 1 pixel. The scale "azimuth angles from Mars north" has been adjusted to take into account this correction.

The residual azimuth angle errors are less than 1 pixel along the horizon and become larger with steeper elevation angles. For the worst case, Lander 2, camera 2, this error is a maximum of 5.7 ± 1 pixel at 60° elevation. The somewhat sinusoidal azimuth-dependent residual elevation error is a maximum of 3 ± 1 pixels for Lander 2, camera 1, and approximately 1 pixel for the other cameras.
